HOME REPORT

AN CNOC BAN

CARINISH
ISLE OF NORTH UIST
HS6 5EJ

Single Survey

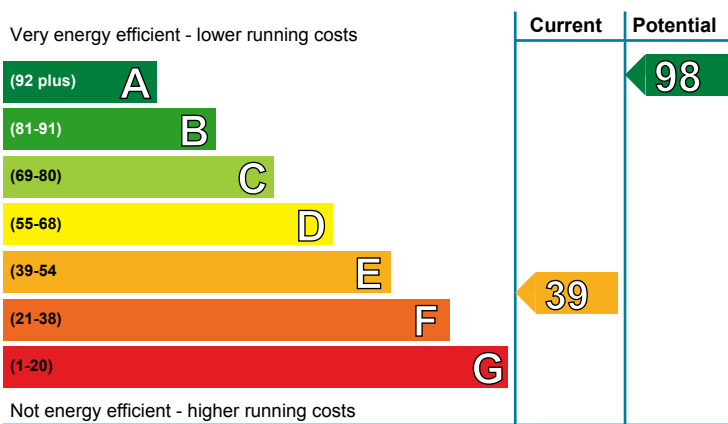
Energy Efficiency Rating

This graph shows the current efficiency of your home, taking into account both energy efficiency and fuel costs. The higher this rating, the lower your fuel bills are likely to be.

Your current rating is **band E (39)**. The average rating for EPCs in Scotland is **band D (61)**.

The potential rating shows the effect of undertaking all of the improvement measures listed within your recommendations report.

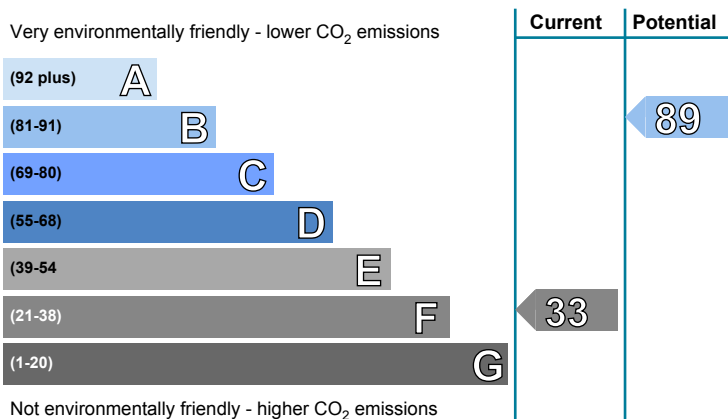
Environmental Impact (CO₂) Rating

This graph shows the effect of your home on the environment in terms of carbon dioxide (CO₂) emissions. The higher the rating, the less impact it has on the environment.

Your current rating is **band F (33)**. The average rating for EPCs in Scotland is **band D (59)**.

The potential rating shows the effect of undertaking all of the improvement measures listed within your recommendations report.
